**ADVANCED ACS VALVE  
SEALING SURFACE COMPATIBILITY  
INVESTIGATION**

G. R. Pfeifer  
H. Wichmann  
Dr. R. Kratzer

This is the final report on the Advanced ACS Valve Sealing Surface Compatibility Investigation performed by The Marquardt Company, CCI Aerospace Corporation, Van Nuys, California, for the Air Force Rocket Propulsion Laboratory under contract FO-4611-70-C-0052 dated 20 April 1970. This task was conducted under the USAF Project 3058. The objective of the program was to determine the causes leading to leakage of the Marquardt Advanced ACS Valve when operated using chlorine pentafluoride or gaseous fluorine as propellants. Objectives of the program were accomplished with design data developed which can lead to a completely successful seat and poppet closure. The period of performance covered by this report is from 15 May 1970 through 15 July 1971. Edwin L. Lantzer, 1st Lt., USAF was the AFRPL Project Engineer for the program.

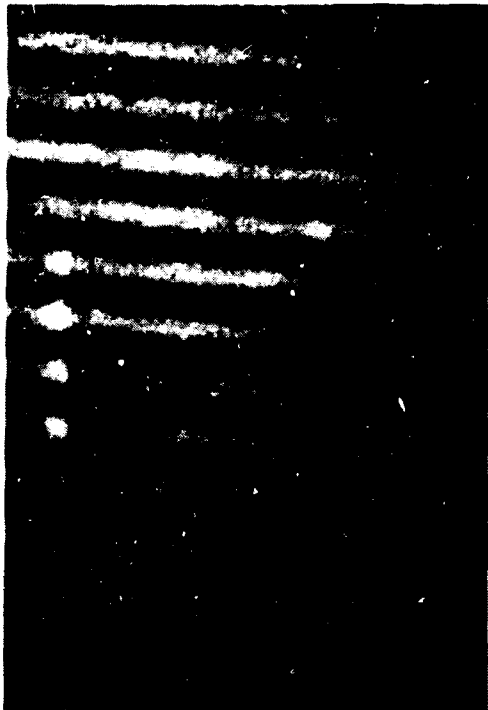
Figure 22 shows surface photographs and interferograms taken of the sample poppet surface before and after exposure to gaseous fluorine. Comparison of the surface photos shows that there was a definite change in character of the surface. In addition, the interferogram of the poppet after exposure was very difficult to even take because of surface textures. The entire surface, although relatively flat, has a surface finish which is dimpled with tiny chemical growths. Examination of the comparable set of photographs from the sample exposed to chlorine pentafluoride (Figure 23) also indicates significant surface character change quite different in nature. The surface appears to have developed a significant number of holes. Comparison of the interferograms indicates about the same finish on the raised portion of the surface, i.e., 1.4 AA for the unexposed part and 1.7 AA microinches for the exposed part.

K-96 STATIC GF<sub>2</sub> EXPOSURE POPPET NO. 2  
210X SURFACE PHOTO BEFORE TEST

K-96 STATIC GF<sub>2</sub> EXPOSURE POPPET NO. 2  
210X INTERFERENCE PHOTO BEFORE TEST

K-96 STATIC GF<sub>2</sub> EXPOSURE POPPET NO. 2  
210X SURFACE PHOTO AFTER TEST

K-96 STATIC GF<sub>2</sub> EXPOSURE POPPET NO. 2  
210X INTERFERENCE PHOTO AFTER TEST

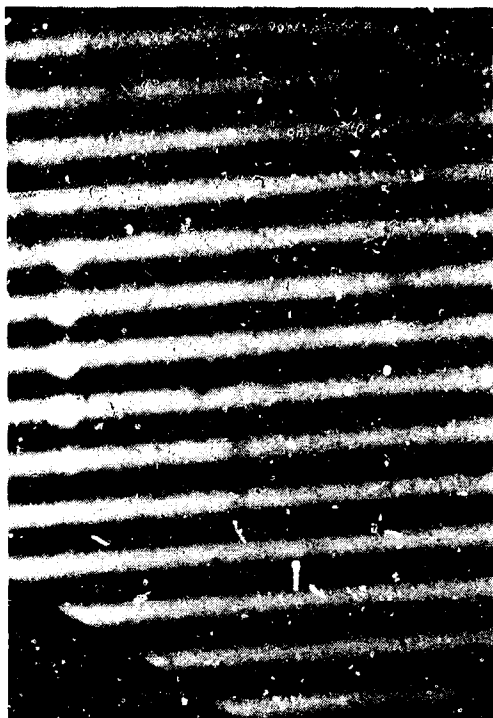
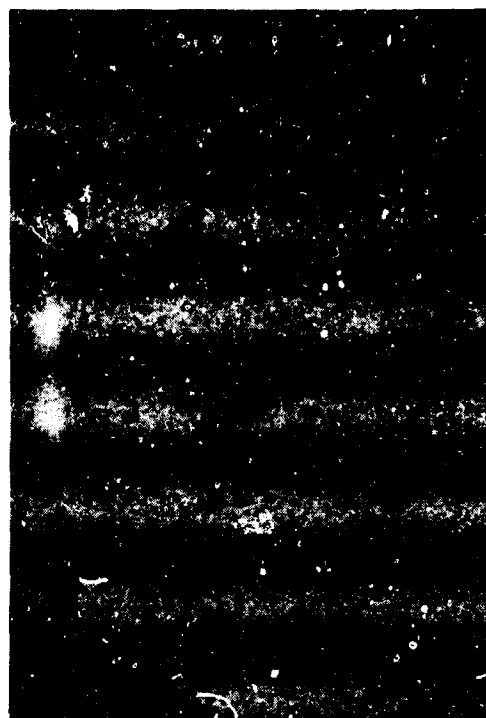
Figure 23

K-96 STATIC CIF<sub>5</sub> EXPOSURE POPPET NO. 3  
210X INTERFERENCE PHOTO BEFORE TEST

K-96 STATIC CIF<sub>5</sub> EXPOSURE POPPET NO. 3  
210X INTERFERENCE PHOTO AFTER TEST

K-96 STATIC CIF<sub>5</sub> EXPOSURE POPPET NO. 3  
210X SURFACE PHOTO BEFORE TEST

K-96 STATIC CIF<sub>5</sub> EXPOSURE POPPET NO. 3  
210X SURFACE PHOTO AFTER TEST

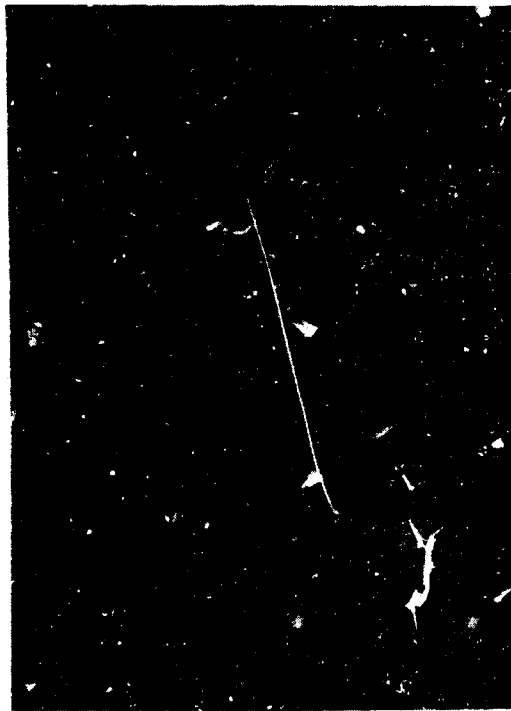
The usefulness of the scanning electron microscope as an analysis tool in examining surfaces was proved in examination of these parts. Figure 24 shows a scanning electron microscope photograph taken at 5000X of the unexposed sample specimen. Electron microscope photographs of the  $\text{ClF}_5$  exposed parts, taken at magnifications of 200X, 1000X and 5000X are shown in Figure 25 for the gaseous fluorine exposed part and in Figure 26 for the part exposed to chlorine pentafluoride. The fluorine exposed poppet is not shown because of the similarity between  $\text{ClF}_5$  and  $\text{GF}_5$  exposed poppets. Comparison of the unexposed surface and that of the poppet surface exposed to gaseous fluorine shows quite clearly why that part surface is rough in appearance.

# K-96 "AS LAPPED" POPPET

S.E.M. PHOTO AT 5000X

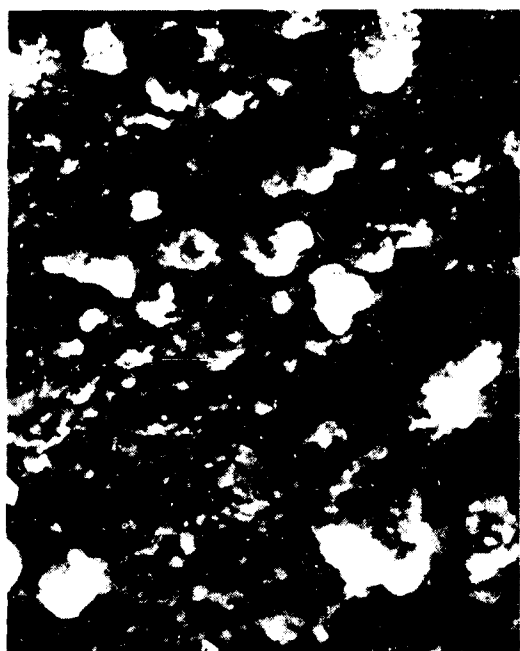
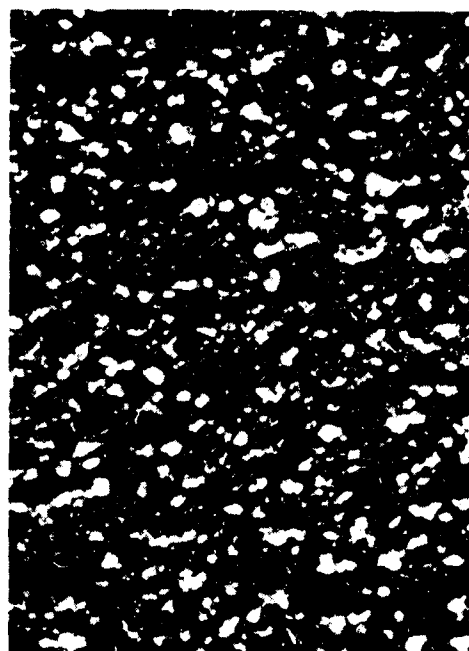
Figure 25

TUNGSTEN CARBIDE K-96 - SAMPLE NO. 2  
S.E.M. PHOTOS AFTER STATIC  $\text{GF}_2$  EXPOSURE

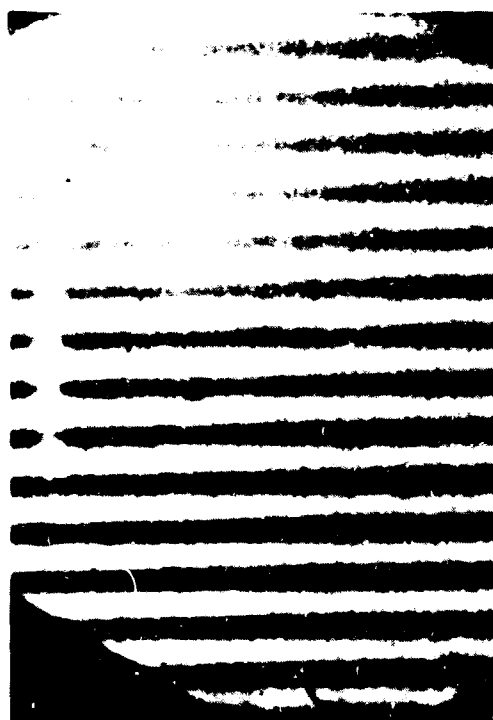
Figure 2s

None of the Nickel 301 parts showed significant degradation as a result of static exposure to either chlorine pentafluoride or gaseous fluorine. The only changes in the parts which were exposed were the growth of random widely separated bumps on the surface which were about 10 microinches high.

Figure 28 shows surface photographs and interferograms taken of the surface of the poppet exposed to gaseous fluorine both before and after exposure. Surface finish in general was not apparently affected by the exposure. Both interferograms indicate about the same surface finish before and after exposure. The surface of the exposed part does indicate the presence of randomly oriented lumps on the surface which were not apparent before exposure or in the scanning electron microscope examination. Figure 29 shows comparable photos of the sample poppet exposed to chlorine pentafluoride. Again, the only surface difference apparent is indicated to be the presence of randomly oriented high spots. These high spots were not identified during examination with the scanning electron microscope. Figure 30 shows electron microscope photographs at 200X, 1000X and 5000X of the sample surfaces which were used as unexposed references. Comparable sets of photographs taken of the gaseous fluorine and chlorine pentafluoride exposed parts are shown in Figures 31 and 32. These photographs indicate essentially no difference between the exposed and nonexposed parts. About the same surface texture is apparent on all parts and the lapping scratches appear

Ni-301 STATIC GF<sub>2</sub> EXPOSURE POPPET NO. 6  
210X INTERFERENCE PHOTO BEFORE TEST

Ni-301 STATIC GF<sub>2</sub> EXPOSURE POPPET NO. 6  
210X INTERFERENCE PHOTO AFTER TEST

Ni-301 STATIC GF<sub>2</sub> EXPOSURE POPPET NO. 6  
210X SURFACE PHOTO BEFORE TEST

Ni-301 STATIC GF<sub>2</sub> EXPOSURE POPPET NO. 6  
210X SURFACE PHOTO AFTER TEST

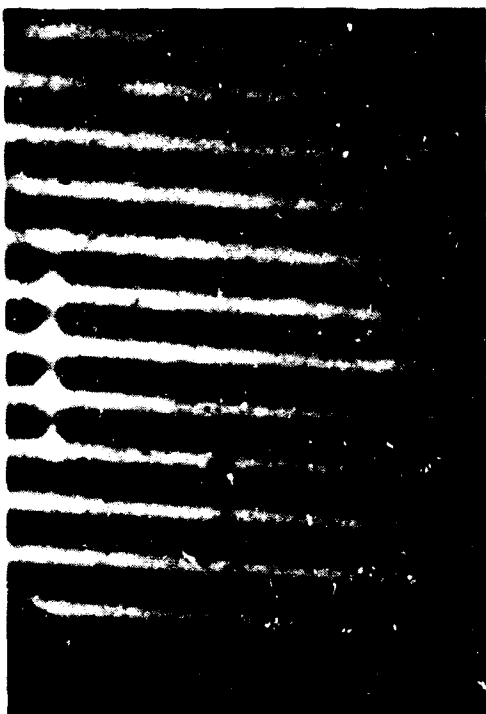
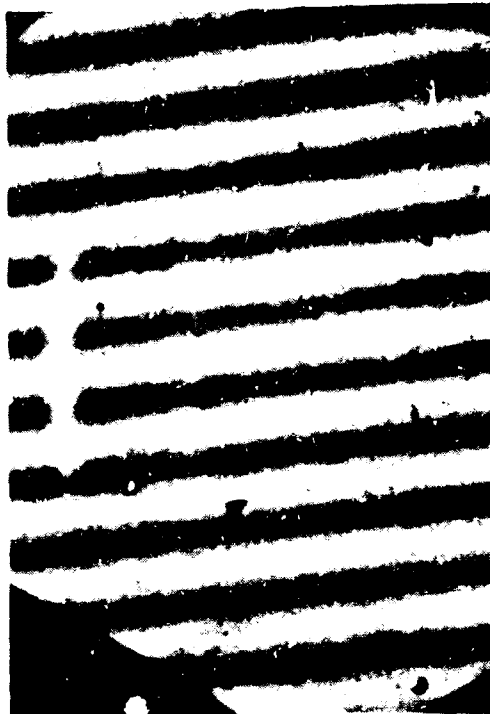
NI-301 STATIC CIF<sub>5</sub> EXPOSURE POPPET NO. 7  
210X SURFACE PHOTO BEFORE TEST

NI-301 STATIC CIF<sub>5</sub> EXPOSURE POPPET NO. 7  
210X SURFACE PHOTO AFTER TEST

NI-301 STATIC CIF<sub>5</sub> EXPOSURE POPPET NO. 7  
210X INTERFERENCE PHOTO BEFORE TEST

NI-301 STATIC CIF<sub>5</sub> EXPOSURE POPPET NO. 7  
210X INTERFERENCE PHOTO AFTER TEST

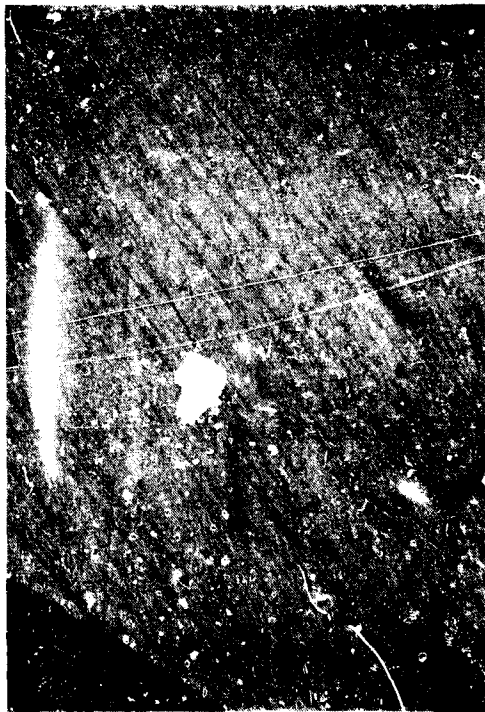
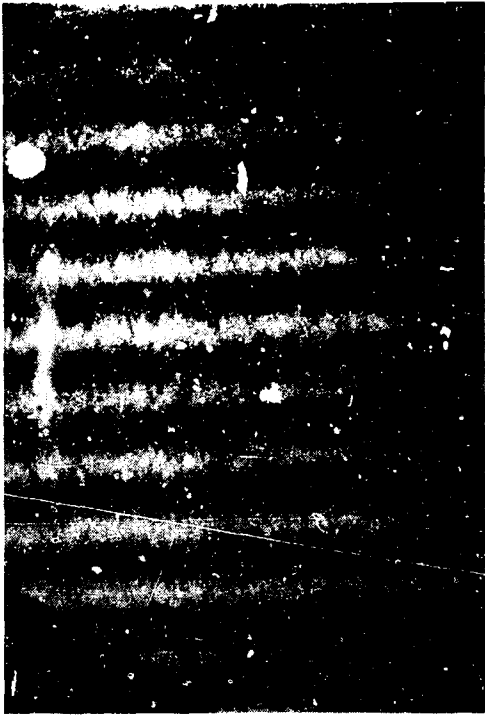
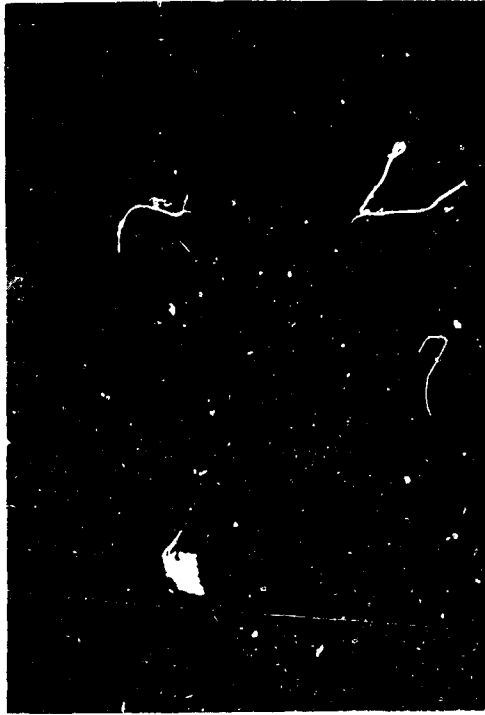
Figure 44 shows interference microscope photographs of the poppet exposed to chlorine pentafluoride prior to and after exposure. The comparable set of photographs for the poppet exposed to gaseous fluorine is not shown because of similarity in the parts. No change in the poppet surface finish is apparent from either set of photographs. The lap marks are still as sharp and clear as on the pre-test condition. Proficorder traces of the poppet profile prior to and after exposure are shown in Figure 45 for the poppet exposed to chlorine pentafluoride. These traces would indicate that none of the minor sharp edged lap marks were removed by the exposure process.

Al<sub>2</sub>O<sub>3</sub> STATIC CIF<sub>5</sub> EXPOSURE POPPET NO. 11  
210X SURFACE PHOTO BEFORE TEST

Al<sub>2</sub>O<sub>3</sub> STATIC CIF<sub>5</sub> EXPOSURE POPPET NO. 11  
210X INTERFERENCE PHOTO BEFORE TEST

Al<sub>2</sub>O<sub>3</sub> STATIC CIF<sub>5</sub> EXPOSURE POPPET NO. 11  
210X INTERFERENCE PHOTO AFTER TEST

AL2 03  
SURFACE PROFILE BEFORE AND AFTER CIF5 STATIC EXPOSURE

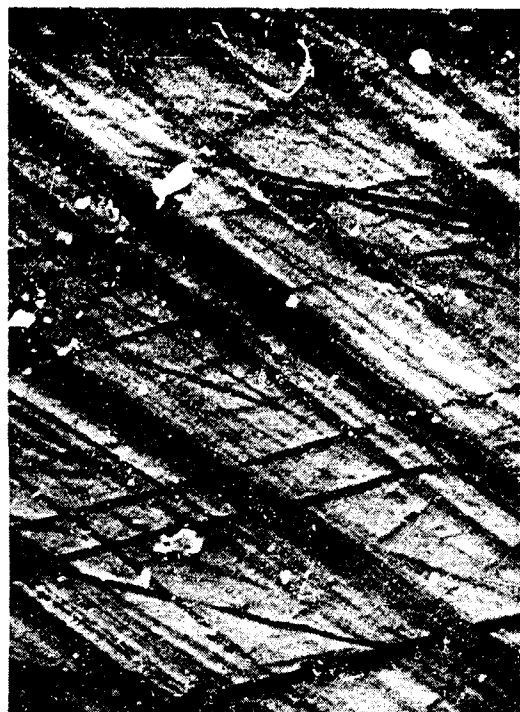
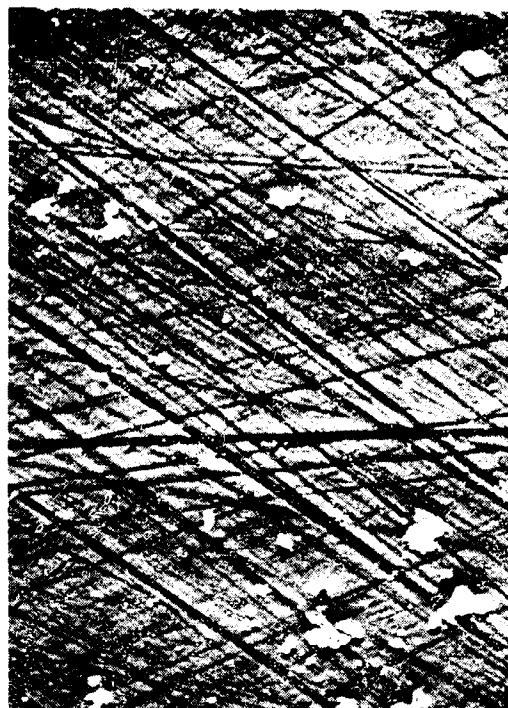
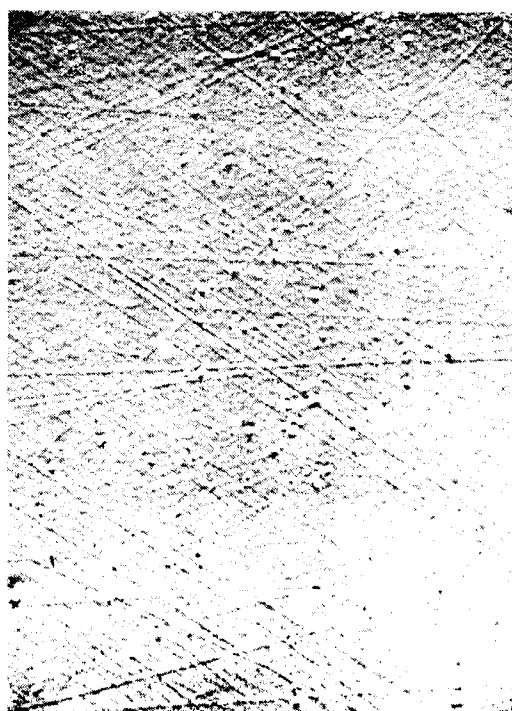
Figure 16

Scanning electron microscope photographs were taken of each of the exposed poppets to further document the surfaces as exposed to chlorine pentafluoride. No S.E.M. photograph was taken on an "as lapped" poppet for comparison due to a shortage of time at the microscope; however, all data indicates that no significant degradation of the surface took place. Figure 46 shows S.E.M. photographs of the sample surface which had been exposed to gaseous fluorine at 200X, 1000X and 5000X. A comparable set of photos is shown in Figure 47 of the sample poppet exposed to chlorine pentafluoride. Both sets of photographs confirm that the reactivity of the aluminum oxide with the propellants was extremely low.

ALUMINUM OXIDE- $\text{Al}_2\text{O}_3$  - SAMPLE NO. 10  
S.E.M. PHOTOS AFTER STATIC  $\text{GF}_2$  EXPOSURE

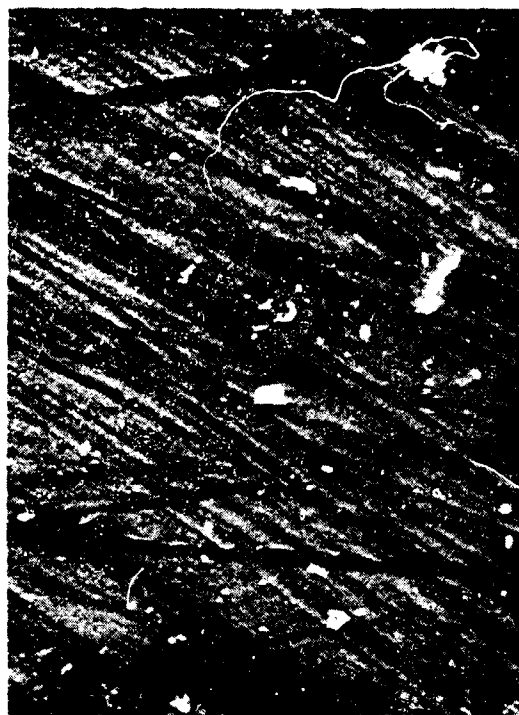
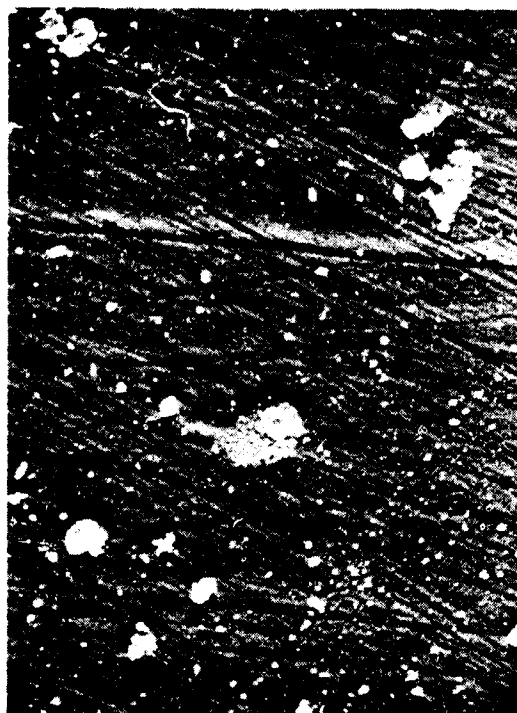
Figure 47

ALUMINUM OXIDE- $\text{Al}_2\text{O}_3$  - SAMPLE NO. 11  
S.E.M. PHOTOS AFTER STATIC  $\text{ClF}_5$  EXPOSURE

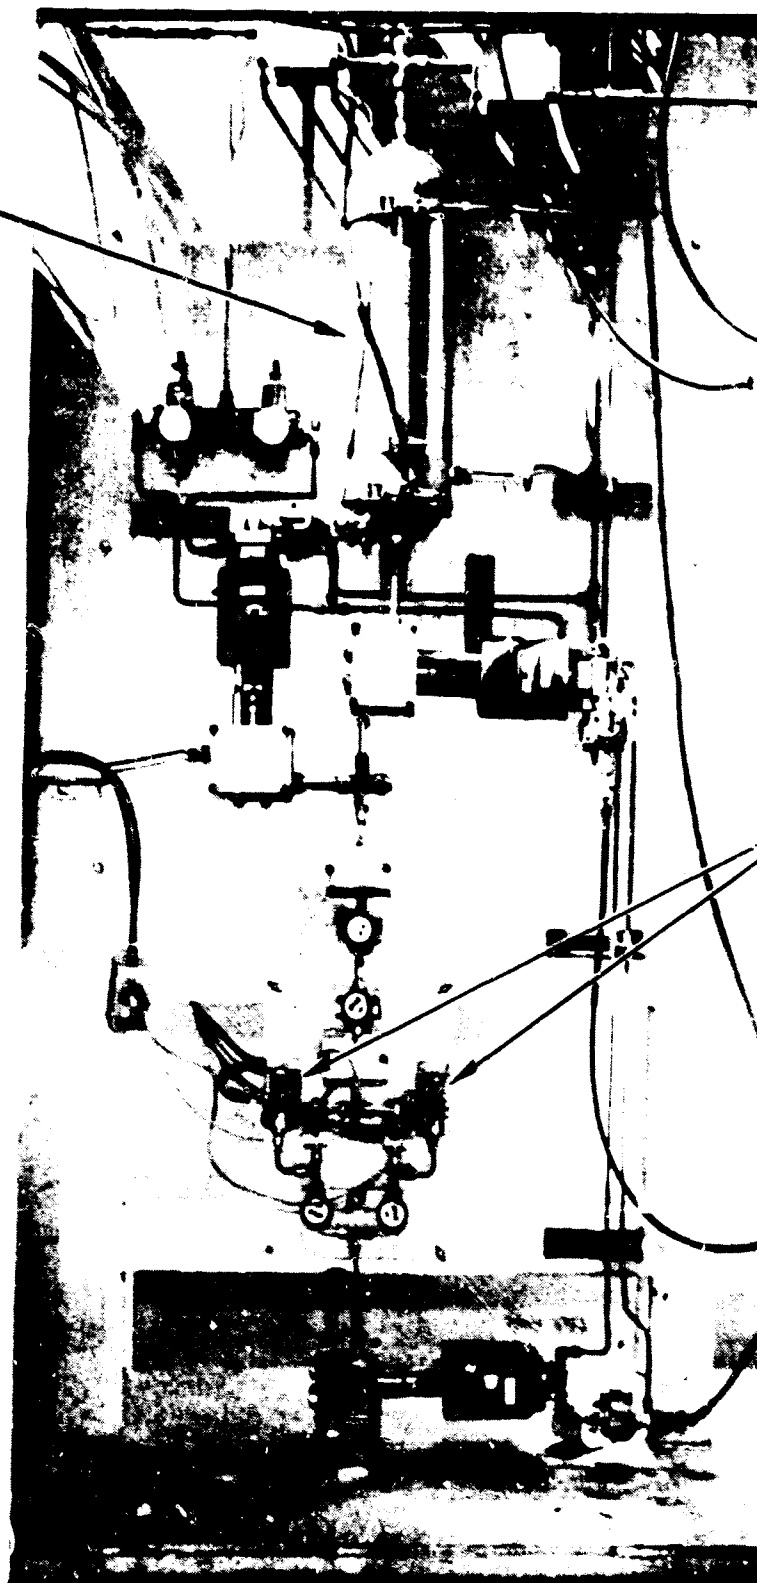
Figure 49

The facility system used for conducting the tests was built specifically for performing the tests. A photo of the system is shown in Figure 49. The system, as designed, is primarily a nonflowing system. Purging capability is provided for emptying the system during installation of valves or for conducting in-test pressure checks. The test consisted of cycling the valves in the nonflowing environment with periodic purges to flush any particles generated during cycling from the seat area. Complete purging was performed at specific valve cumulative cycle intervals to conduct helium pressure leakage checks. In general, flushing was carried out at 10,000 cycle intervals with leakage tests conducted at 1, 100, 1000, 5000, 20,000 and 100,000 accumulated valve cycles.

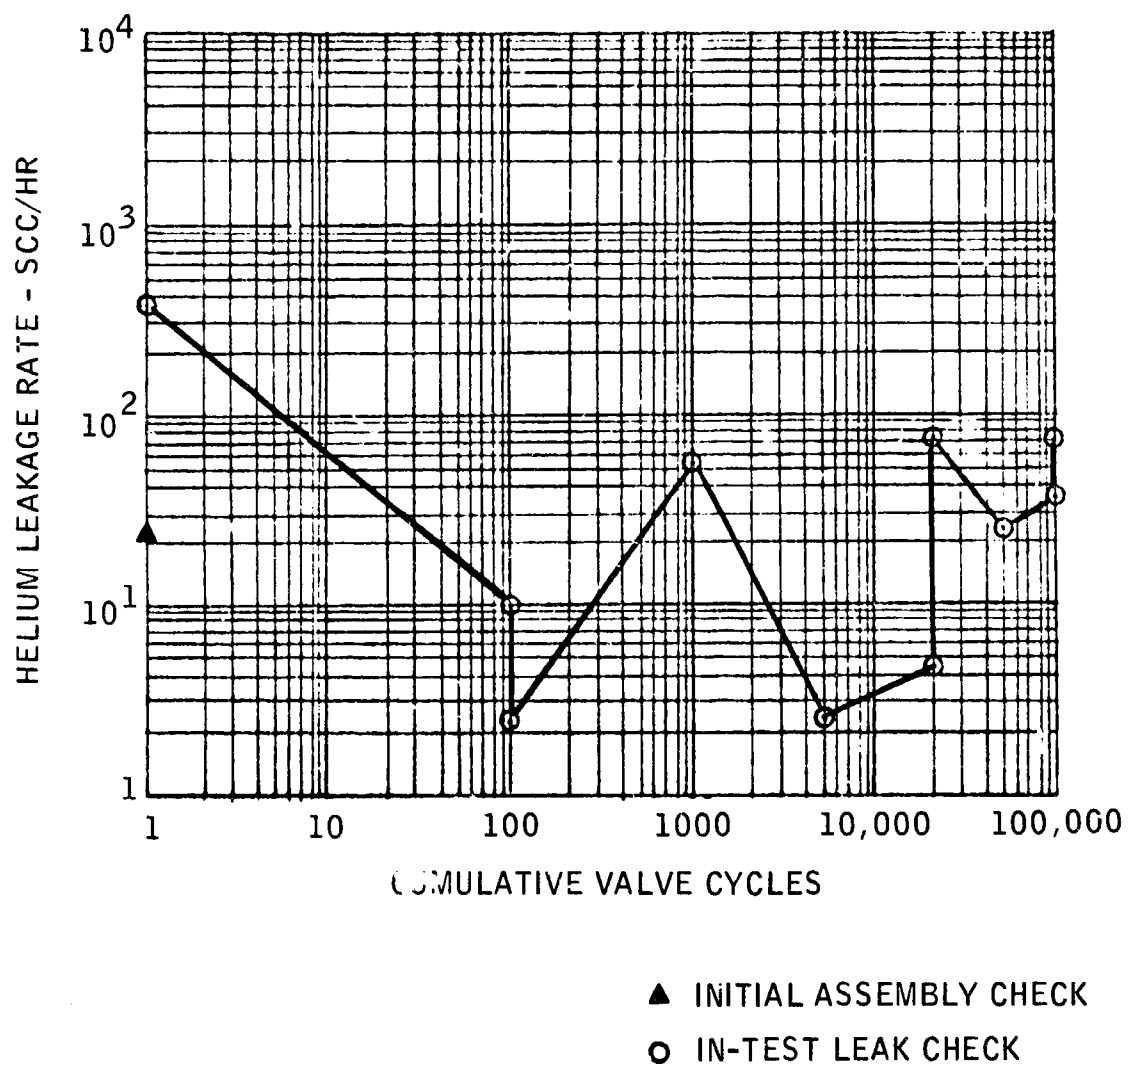
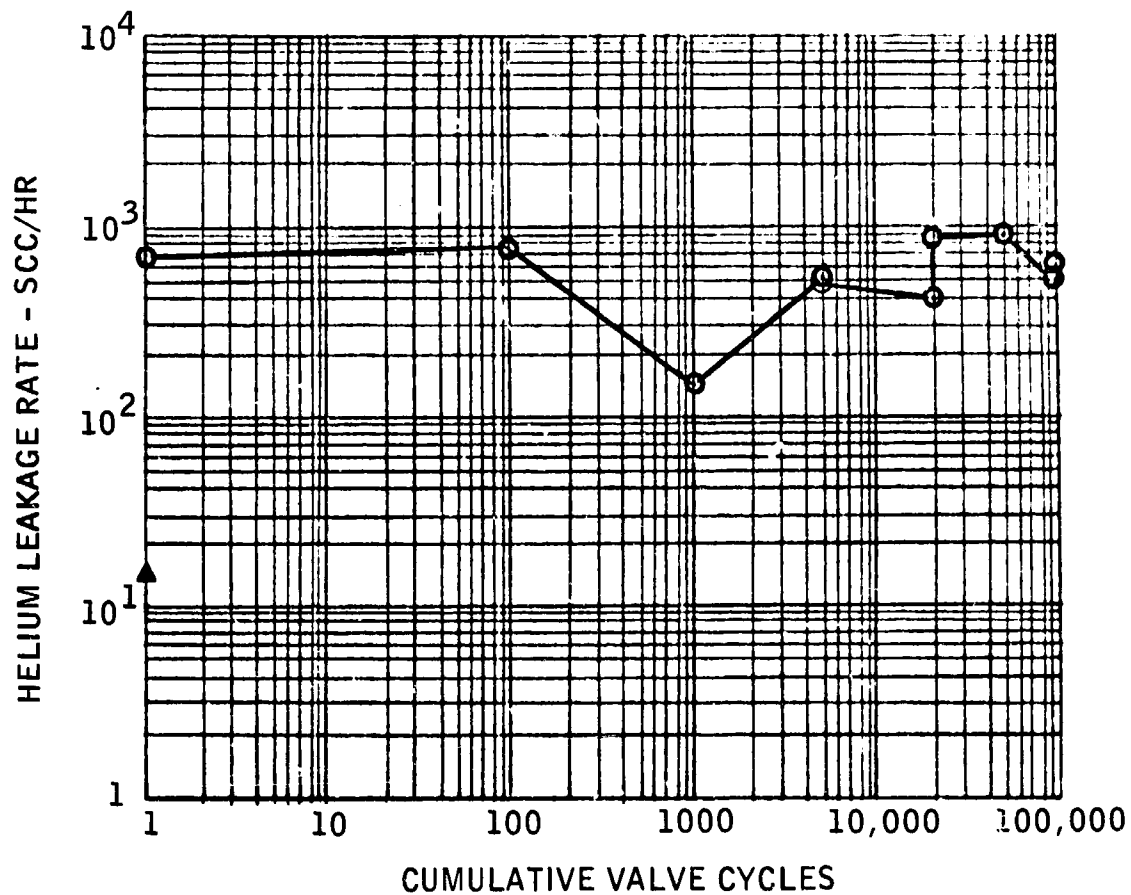
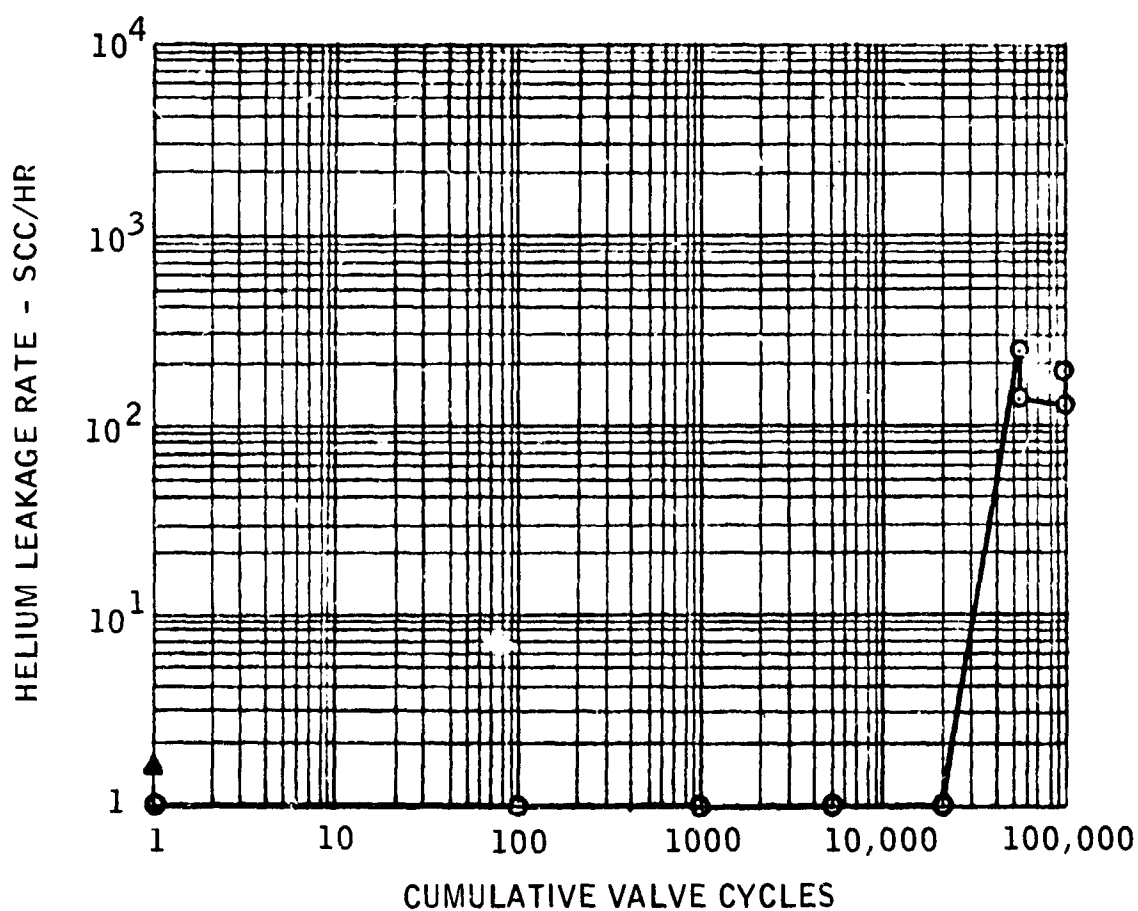
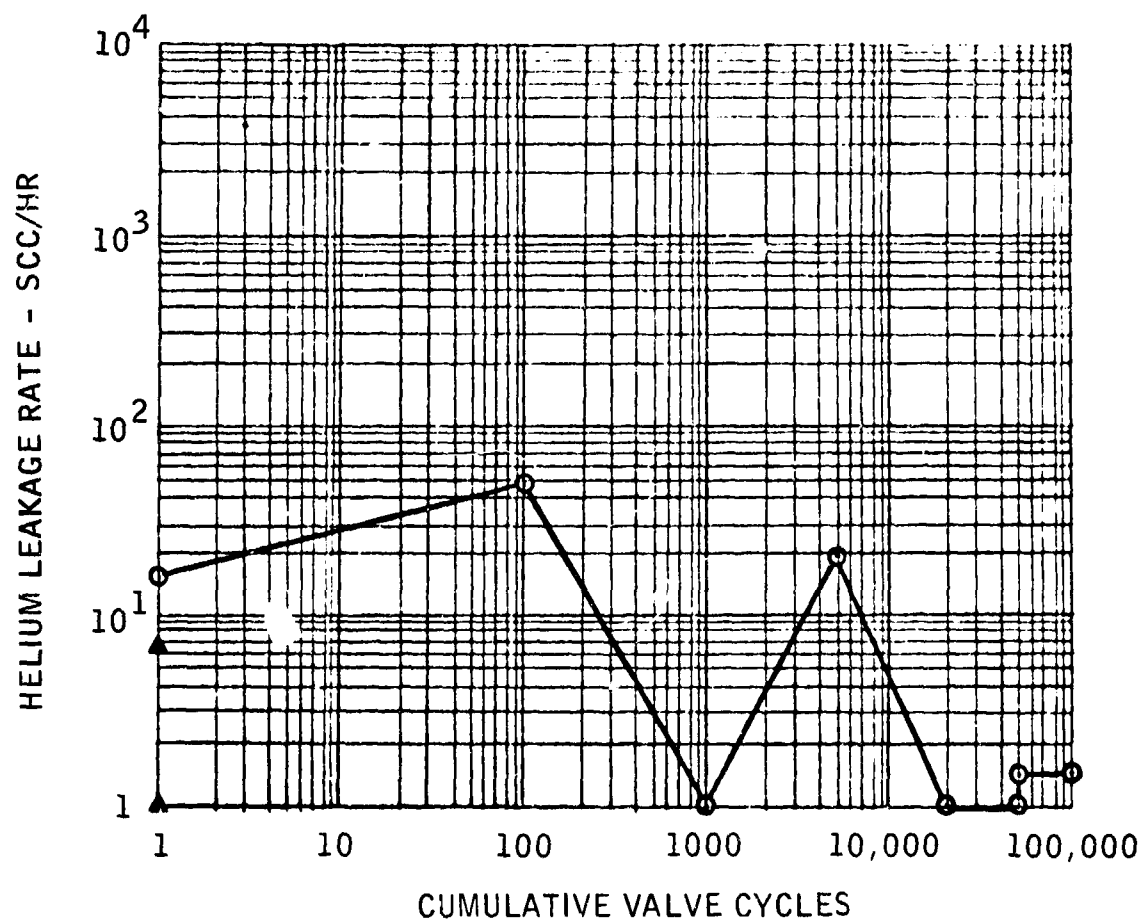
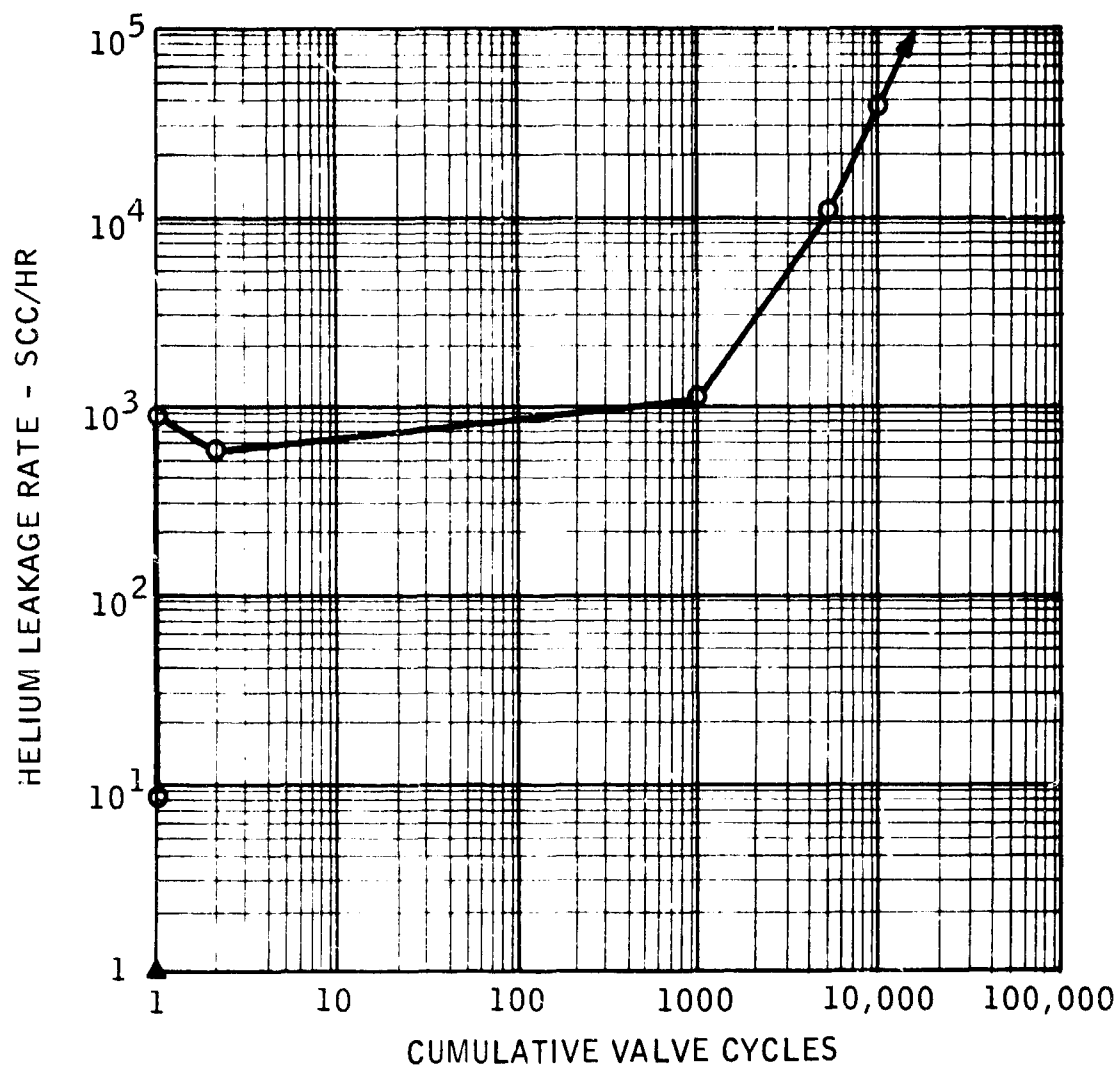
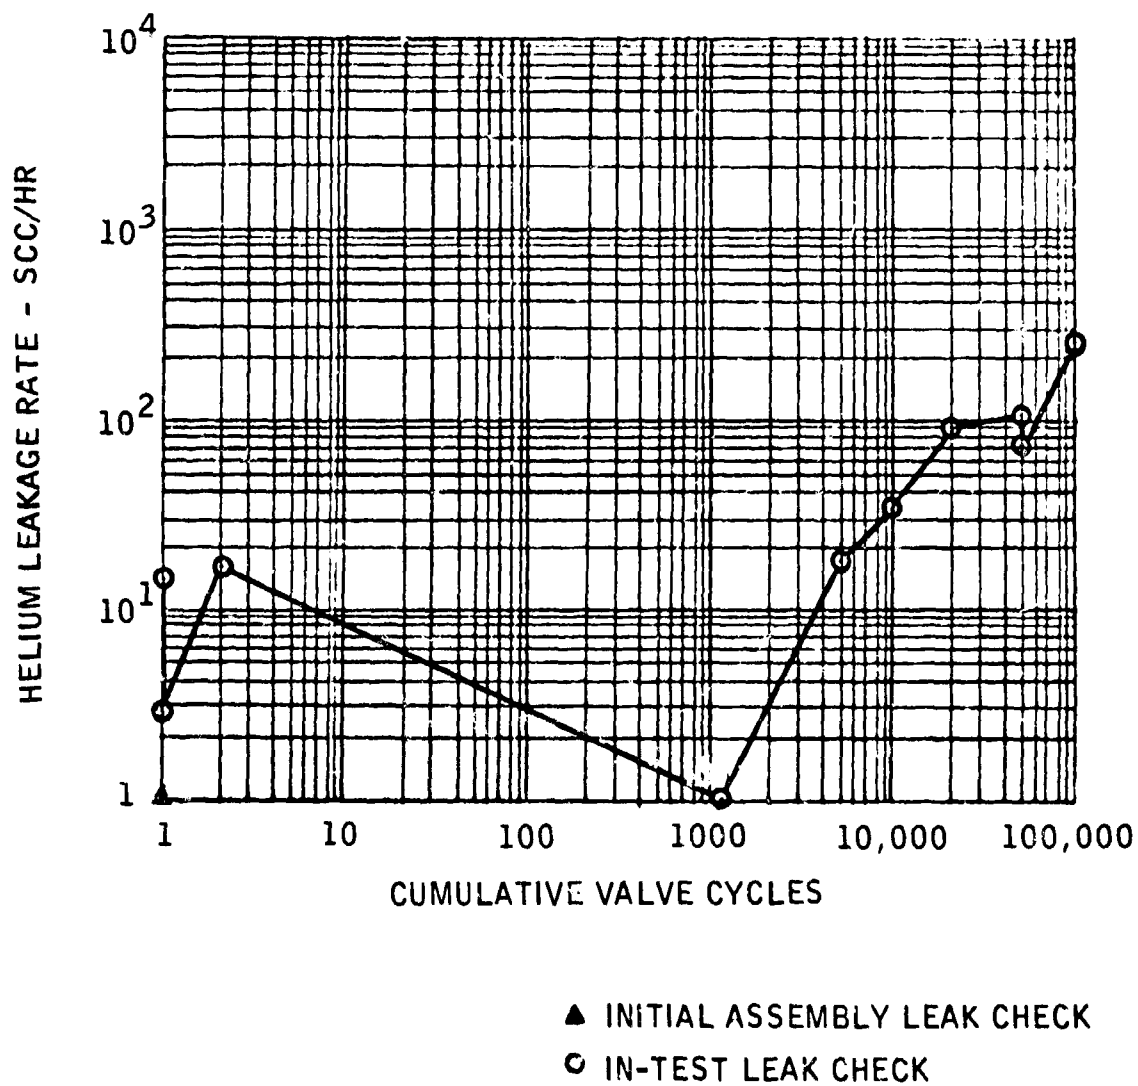
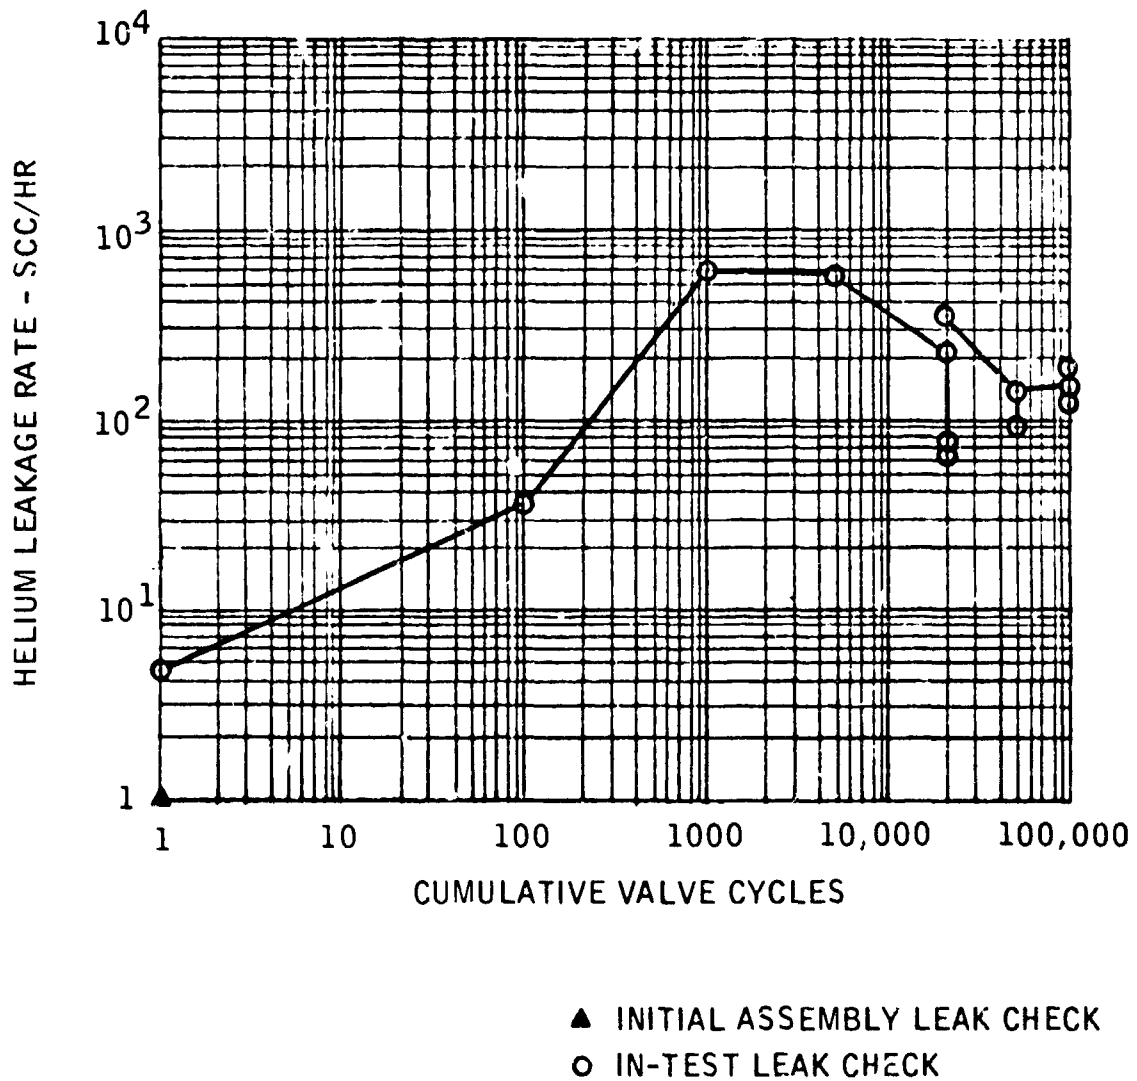
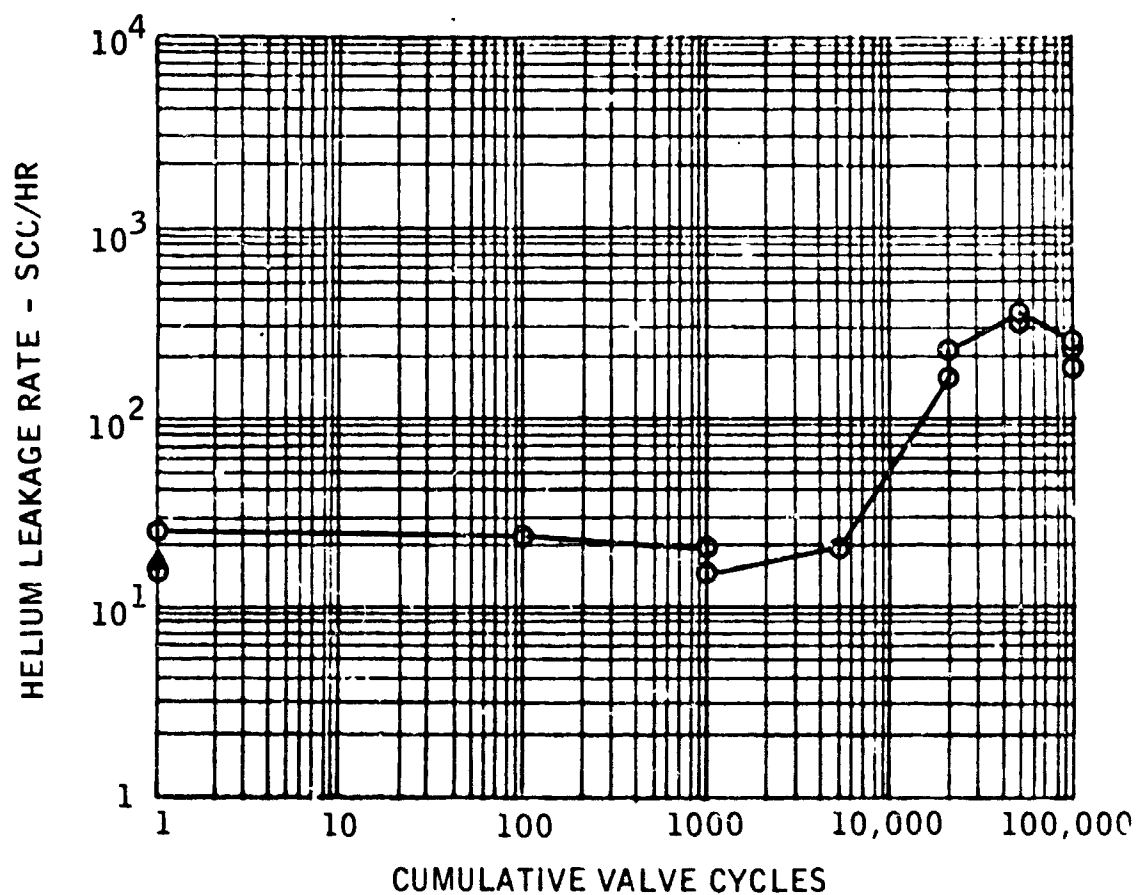
Figures 50 through 57 show the leakage rates measured on each of the valve configurations as a function of valve cycles. The figures are presented in the order in which the valves were tested. Some of the valve leakage tests demonstrated considerable variability between successive tests. This variability is believed to be more a function of total valve and seat to poppet to seat seal performance than test setup problems. Several checks were made between initial buildup leakage rates measured by positive displacement of water in burette and the initial leakage test made prior to fluorine passivation of the valves in the propellant test facility. These tests indicated excellent correlation (within one or two SCCH measured difference) of the two leak rate measurement techniques. Several sources of problems in determining actual leakage in the test facility are apparent. Three of the valves (Ni-301, K-96 and WC) showed a significant change in leak rate immediately after  $\text{GF}_2$  passivation. The immediate rise in excessive leak rates for these valves suggests that a static seal in the valve assembly which has a leak path parallel to the seat seal failed at passivation causing a significant percentage of the apparent leakage.

Only one valve nearly met the leakage goal of less than 30 SCCH of helium leakage at 450 psig inlet pressure throughout the test. This was the boron carbide tested at low impact force levels. At completion of the test leakage from this valve was only 1.4 SCCH. However, during the test period, one leakage point at 100 accumulated cycles was 47 SCCH. The K-96 valve marginally met the leakage goal periodically through the test cycle with some points above and some below the leakage goal. The

carbide poppet and seat tested at high impact met the leakage goal up to and including 20,000 cycles and then leakage increased at a rapid rate at 50,000 and 100,000 cycles. The remainder of the valves tested demonstrated acceptable leakage rates up to the 1000 to 5000 cycle range with the exception of the pure tungsten carbide poppet and seat which leaked almost 1000 SCCH immediately after passivation and progressively leaked worse as a function of added valve cycles and the Ni-301 valve which leaked at a consistently high rate after  $GF_2$  passivation.

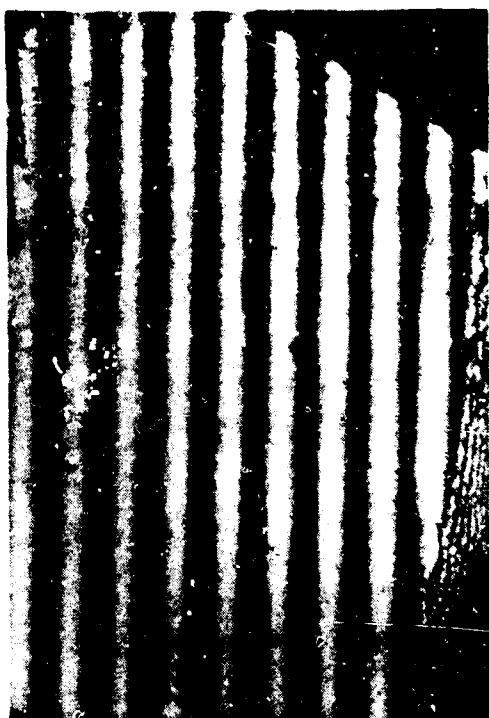
The Ni-301 parts tested were about the best of all the test parts in terms of surface finish of the poppet and seat at the time of valve buildup. During the test period, however, the seating surfaces were degraded significantly. Figure 58 shows surface photographs and interferograms of the seat land surface prior to and after subjecting the seat to 100,000 cycles at low impact in chlorine pentafluoride. The original seat surface was considerably less than one microinch in surface finish after lapping. After testing, the seat surface subjected to valve closing impact was significantly degraded with the presence of a large concentration of lumps on the impact surfaces. The profilometer trace comparisons of the seat surface before and after testing (Figure 59) show that the mean level of the seating surface is the same as prior to testing with the surface lumps rising above the surface to a height of 30 to 35 micro-inches.

NI-301 SEAT NO. 8 BEFORE LOW IMPACT  
VALVE TEST IN CIF<sub>5</sub> - 210X INTERFERENCE PHOTO

NI-301 SEAT NO. 8 AFTER LOW IMPACT  
VALVE TEST IN CIF<sub>5</sub> - 210X INTERFERENCE PHOTO

NI-301 SEAT NO. 8 BEFORE LOW IMPACT  
VALVE TEST IN CIF<sub>5</sub> - 210X SURFACE PHOTO

NI-301 SEAT NO. 8 AFTER LOW IMPACT  
VALVE TEST IN CIF<sub>5</sub> - 210X SURFACE PHOTO

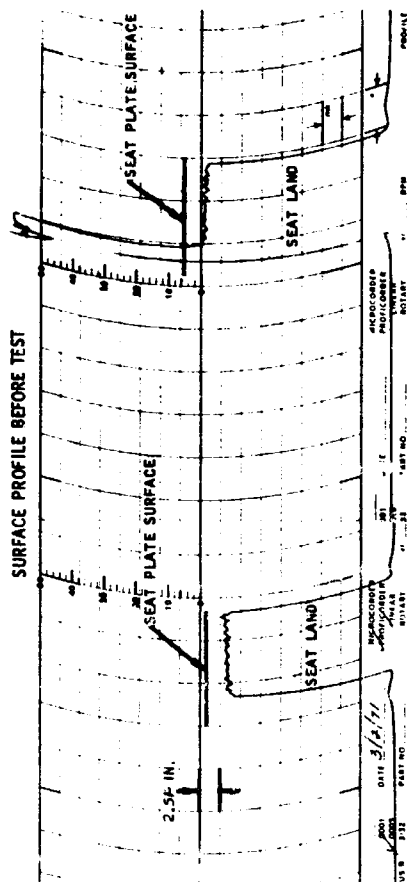
Figure 59

# NI-301 SEAT SURFACE PROFILE BEFORE AND AFTER 100,000 CYCLE VALVE TEST - LOW IMPACT - CIF5

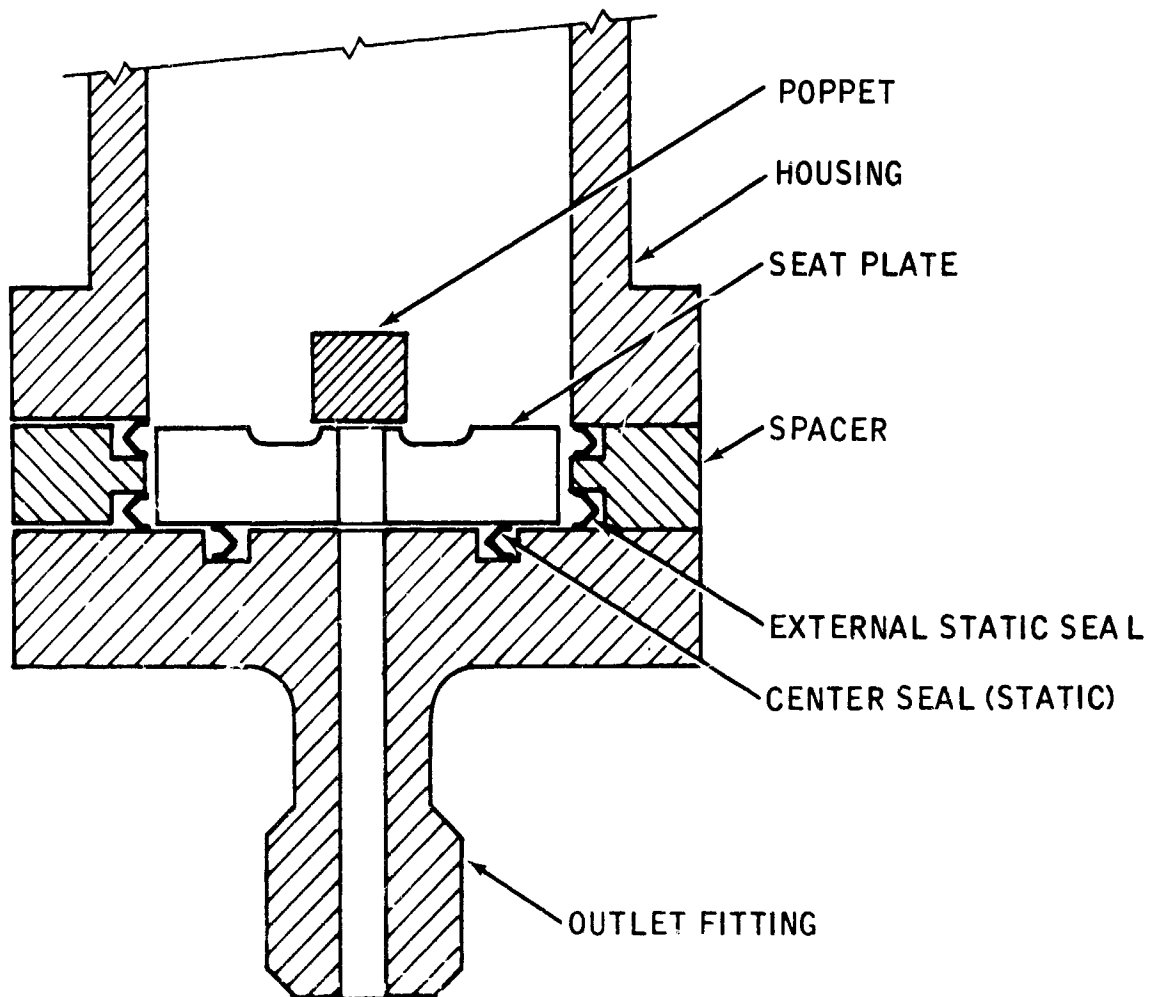
Figure 64

In the case of the nickel 301 valve tested at low impact, it is concluded that the failure of the test valve to adequately seal resulted from two sources:

1. Primary cause of measured leakage was probably failure of the valve downstream center seal during the passivation procedure.
2. A contributing source of probable additional (not verified) leakage was degradation of the poppet and seat seating surfaces through adhesive wear, resulting from extremely minor lateral motion of the poppet, relative to the seat after valve closure. This action resulted in a positive buildup of material in the poppet center section with resultant rounding of the sealing surface.

Although satisfactory leakage characteristics were not demonstrated using Ni-301, it still may be possible that properly used, the material may be satisfactory. From appearance of the statically exposed parts, it is apparent that the material retains a smooth surface without the influence of impact loads. Secondly, the seat and poppet tested at low impact loads performed better than previous tests at higher closing impact loads. Thus, the material may be made to perform satisfactorily if a design is conceived which could lower the impact loads further still. An alternate technique, probably not too promising, would be to increase impact loads above seat loads tested to date. Since the film is "tenacious", it might be possible to batter the thick films formed under impact flat enough to retain a passable sealing surface. The nickel surfaces may stand significant additional loading before erosion starts to occur. In conjunction with either approach, possibility of lateral motion of the poppet relative to the seat after initial contact should be eliminated as far as possible. Potential sliding, even at the low loads, is undesirable. A design change to reduce the possibility of sliding would help in obtaining reasonably satisfactory performance using Ni-301.

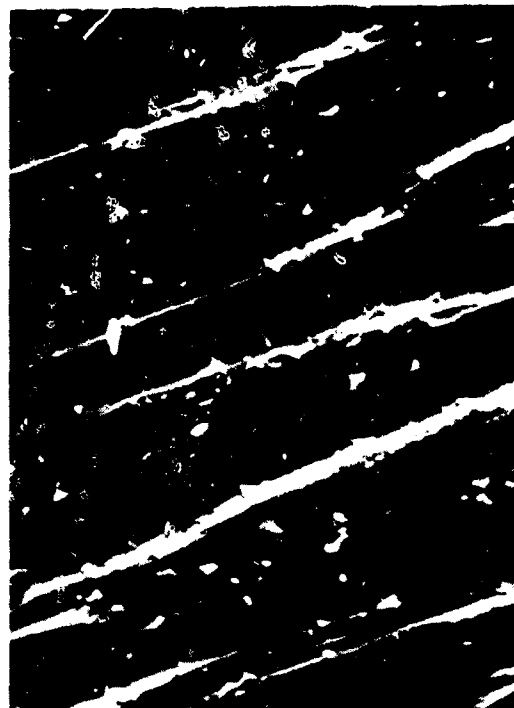
S.E.M. PHOTOS AFTER 100,000 CYCLE - CIF<sub>5</sub> VALVE TEST (NORMAL IMPACT)

The hypothesis that the bumper striking with only one side causes the main armature to oilcan and eccentrically flex with resultant dragging of the poppet across the seat is again a significant probability contributing to the valve seat wear and resultant leakage. Why the seat and poppet functioned as well as they did up to 20,000 cycles, whereafter both failed, as evidenced by leakage rate measurements and surface finish degradation is difficult to explain. However, the seating location is highly repeatable and it is well within possibility that the seat and poppet grooves continued to mesh smoothly until late in the test cycle. It may also be possible that erosion of the seat resulted in loose granules which were not completely removed from the seating area during the flush or purge cycles.
